Pre-CERCLIS Screening Checklist

**Willow Park Municipal System
516 Ranch House Road
Willow Park, Parker County, Texas
TXD PENDING**

Willow Park Municipal System
PWS ID# 1840027
Willow Park, Parker County, Texas

PRE-CERCLIS FIELD SCREENING CHECKLIST

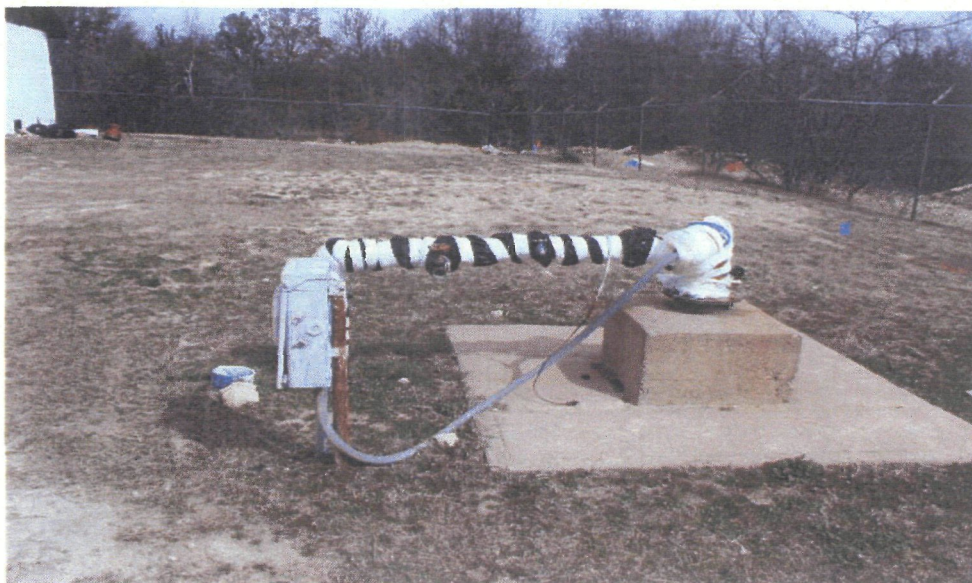
Based on the site inspection conducted on March 6, 2007, the POE 011 of Willow Park Municipal System is located at residential area. No potential sources of hazardous substances could be located in the vicinity of POE 011.

Picture 1 POE011(Willow Springs Oaks Pump Station) where has TCE detection
Facing north, picture was taken by Xiaohong Wang on March 6, 2007

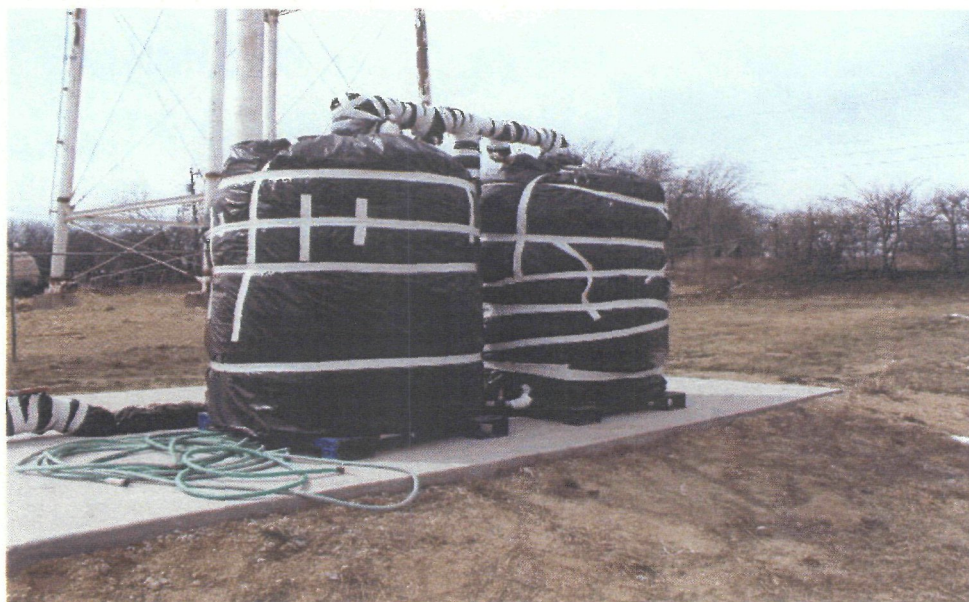
Collected date	TCE concentration before the filter (ppb)	Above MCL	TCE concentration after the filter (ppb)	Above MCL or PCL
06/20/2006(first sample using filters)	6.8	Y	<2.0	N
06/26/2006	6.1	Y	<2.0	N
07/06/2006	5.2	Y	<2.0	N
08/11/2006	2.2	N	<2.0	N
09/11/2006	3.9	N	<2.0	N
10/05/2006	5.4	Y	<2.0	N
11/16/2006	5.7	Y	<2.0	N
12/20/2006	5.4	Y	<2.0	N
01/26/2007	4.7	N	<2.0	N
02/6/2007	3.5	N	<2.0	N

Picture 2 Two filters installed on Willow Springs Oaks Pump Station
Facing east, picture was taken by Xiaohong Wang on March 6, 2007

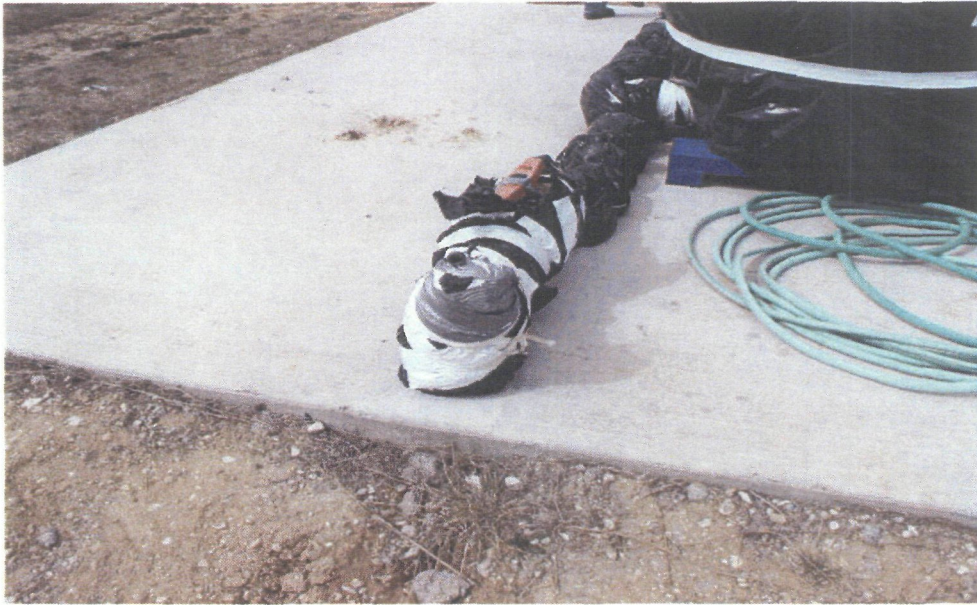
Picture 3 The well outlet before the filter at Willow Springs Oaks Pump Station
Facing west, picture was taken by Xiaohong Wang on March 6, 2007

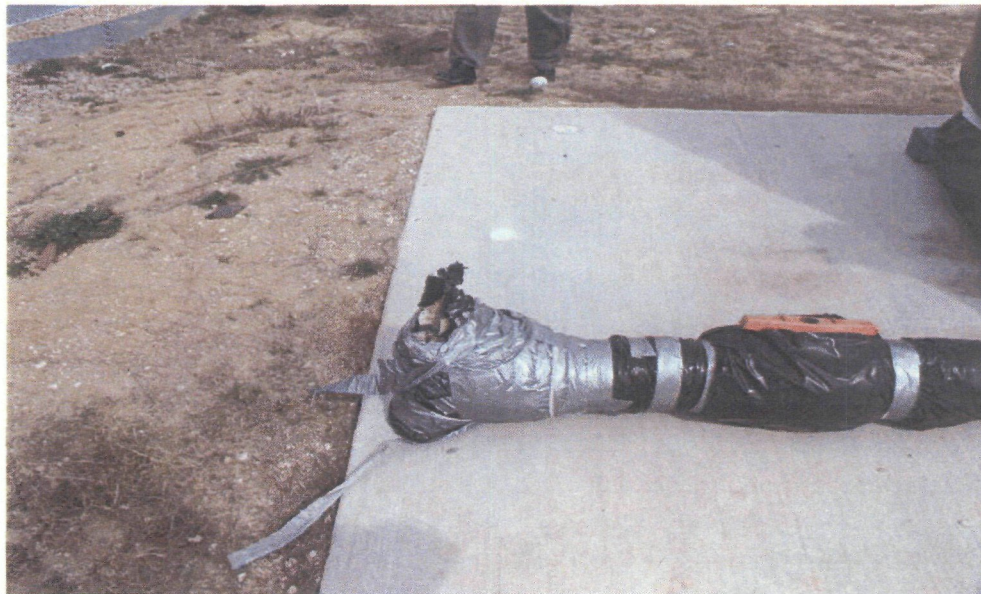
Picture 4 The well outlet after the filter at Willow Springs Oaks Pump Station
Facing west, picture was taken by Xiaohong Wang on March 6, 2007

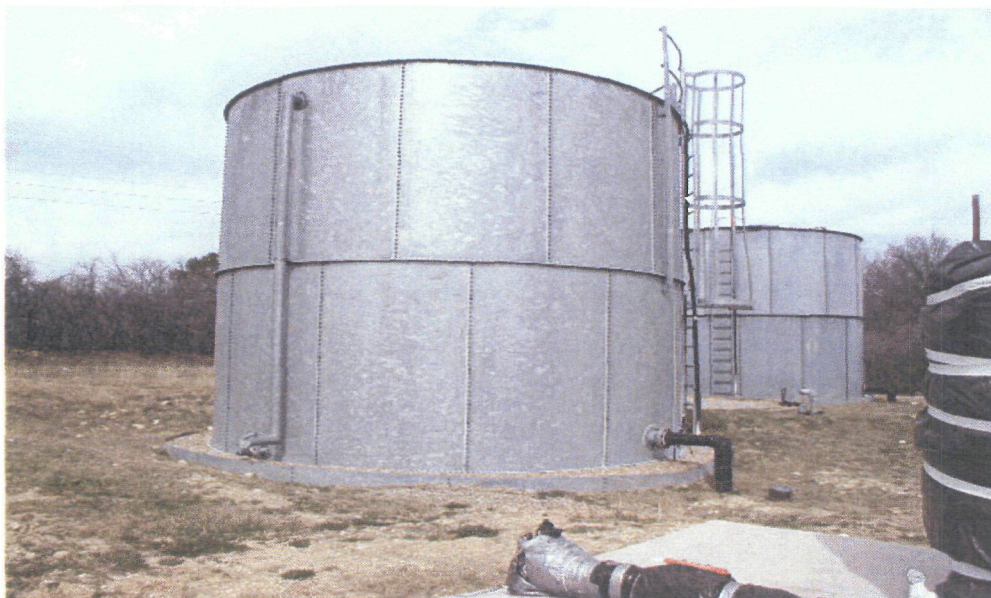
Picture 5 Two aboveground tanks at Willow Springs Oaks Pump Station
Facing north, picture was taken by Xiaohong Wang on March 6, 2007

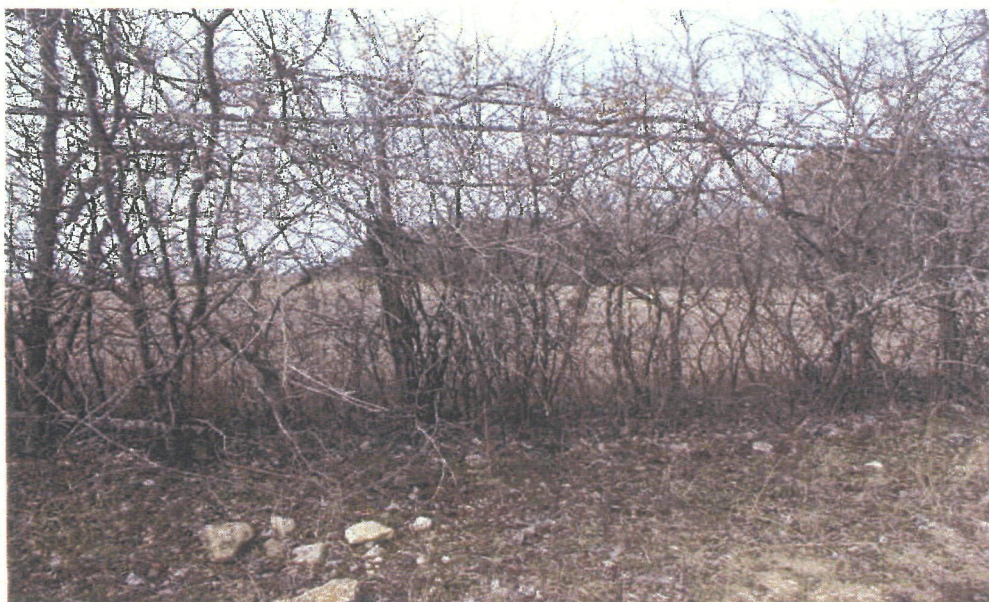
Picture 6 The west side of the Willow Spring Oaks Pump Station
Facing west, picture was taken by Xiaohong Wang on March 6, 2007

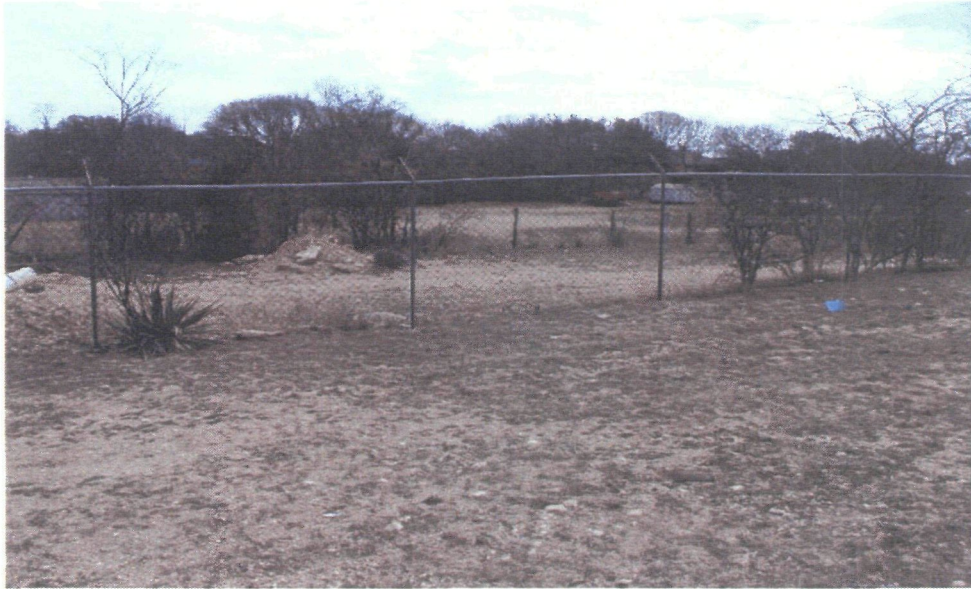
Picture 7 East side of the Willow Springs Oaks Pump Station
Facing the east, picture was taken by Xiaohong Wang on March 6, 2007

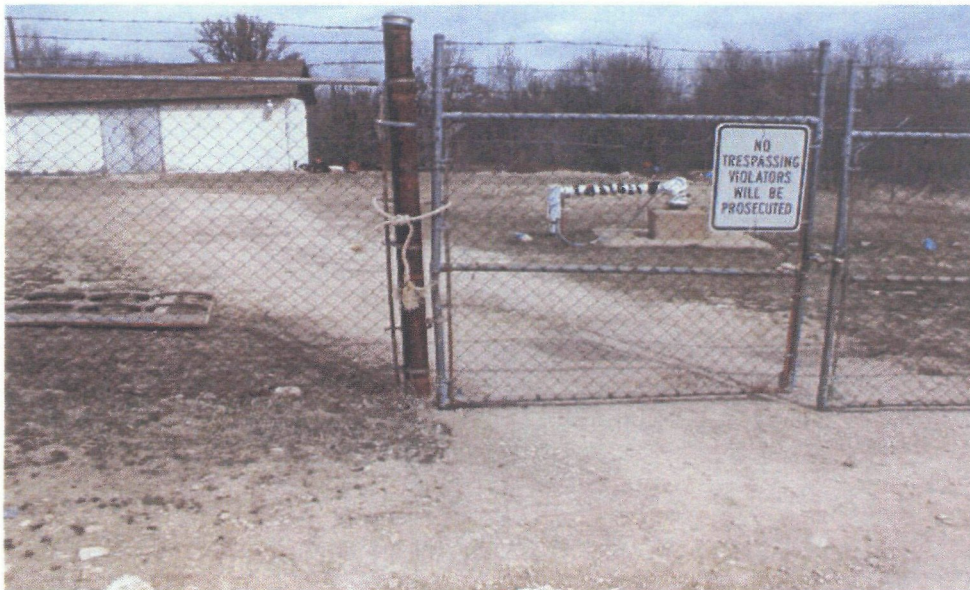
Picture 8 Front of the Willow Springs Oaks Pump Station
Facing north, picture was taken by Xiaohong Wang on March 6, 2007

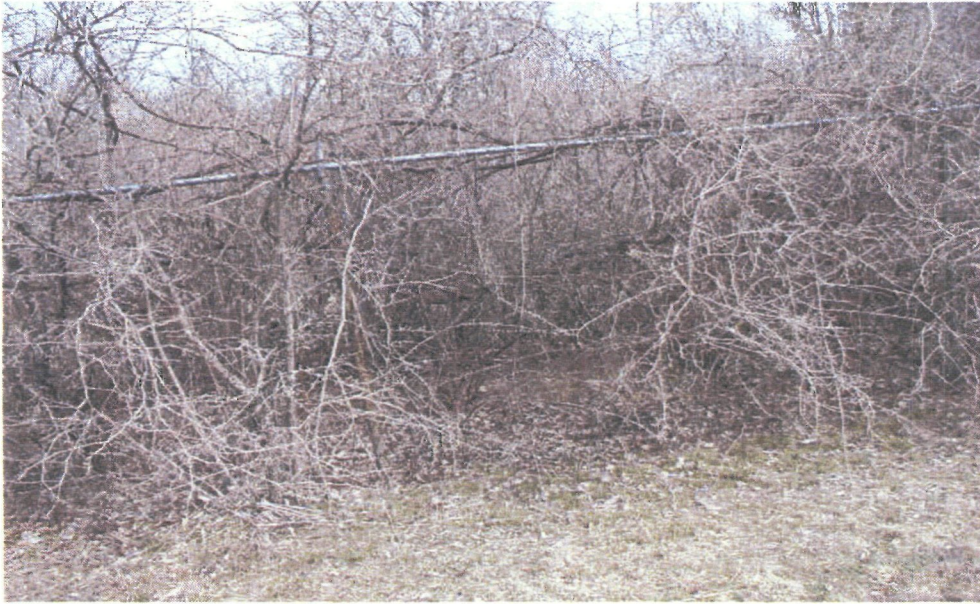
Picture 9 The back of the Willow Springs Oaks Pump Station
Facing north, picture was taken by Xiaohong Wang on March 6, 2007

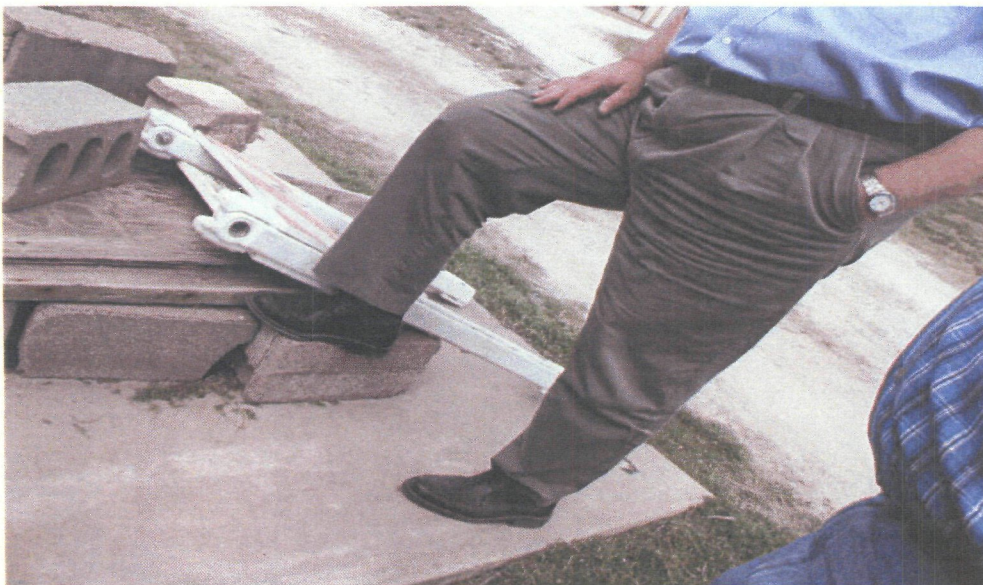
Picture 10 Parker County Airport Well#1
Facing northeast, picture was taken by Xiaohong Wang on March 6, 2007

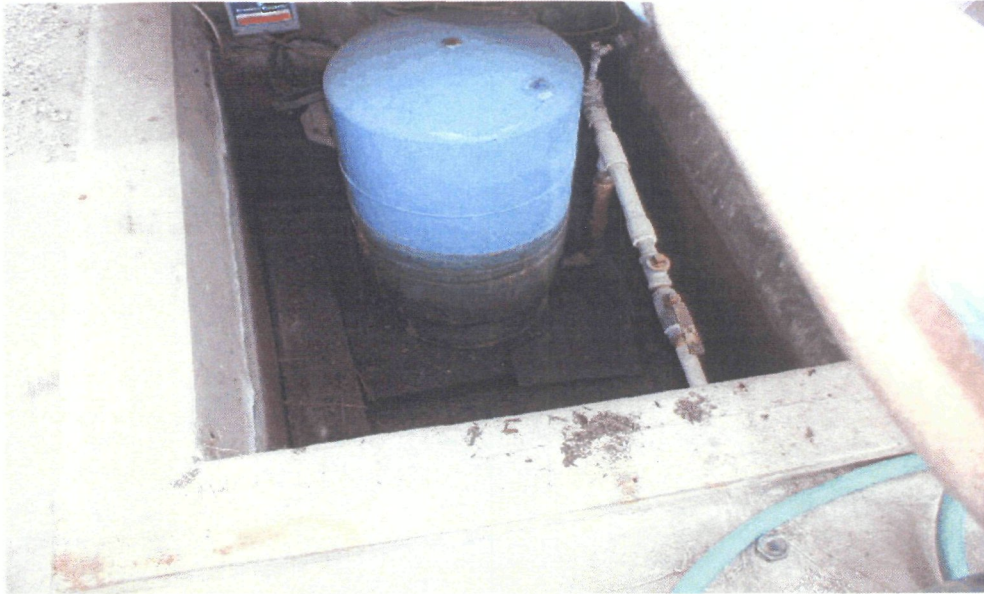
Because the TCE concentration (12.2 ppb) in Barnett #2 well exceeded its MCL, the well was inspected also on March 6, 2007. Based on the site inspection, the well is located below ground in between two aboveground storage tanks at Parker County Airport. It was also found that there are two underground tanks located next to the well as shown in Figure 3. Mr. Barnett cannot provide much information about the well and historical use for above and underground tanks located next to the well. Based on the information available in TCEQ PST program, both underground storage tanks had been out of service since approximately 1998. Based on the latest TCEQ letter dated July 27, 2001, TCEQ required Parker County Airport to either permanently remove both underground tanks from service or require for variance in order to return the UST system to operation. No response from Parker County Airport is located in the file. Based on the site inspection for the well on March 6, 2007, by opening the well cover, the walls of the pit were wet below the high water mark with oil residue as shown in Picture 11. The drain was full of water. There is some water on the bottom of the pit. It appeared that the water backflowed up through drain and filled pit and submerged unsealed well head. Since TCE (12.2 ppb) was detected in the well next to the underground storage tanks and there is no information about the historical use of the underground storage tanks available, further sampling investigation is needed. Parker County Airport is located within 0.5 mile from the POE 011. There are no dry cleaners located within one mile of the site.

Picture 11 Parker County Airport well# 2 after cover was removed
Facing the north, picture was taken by Xiaohong Wang on March 6, 2007

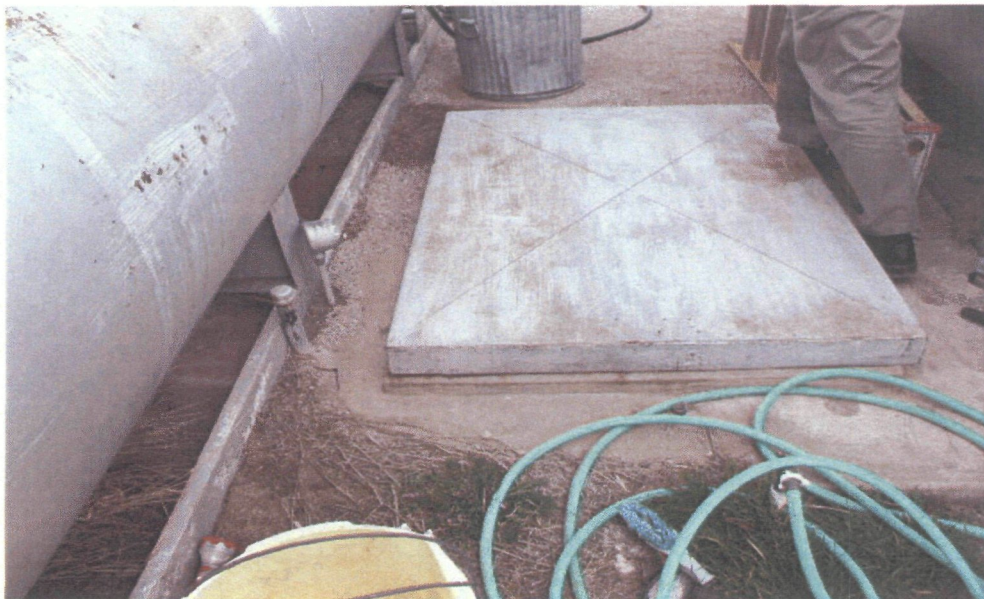
Picture 12 Parker County Airport Well#2 with cover
Facing the north, picture was taken by Xiaohong Wang on March 6, 2007

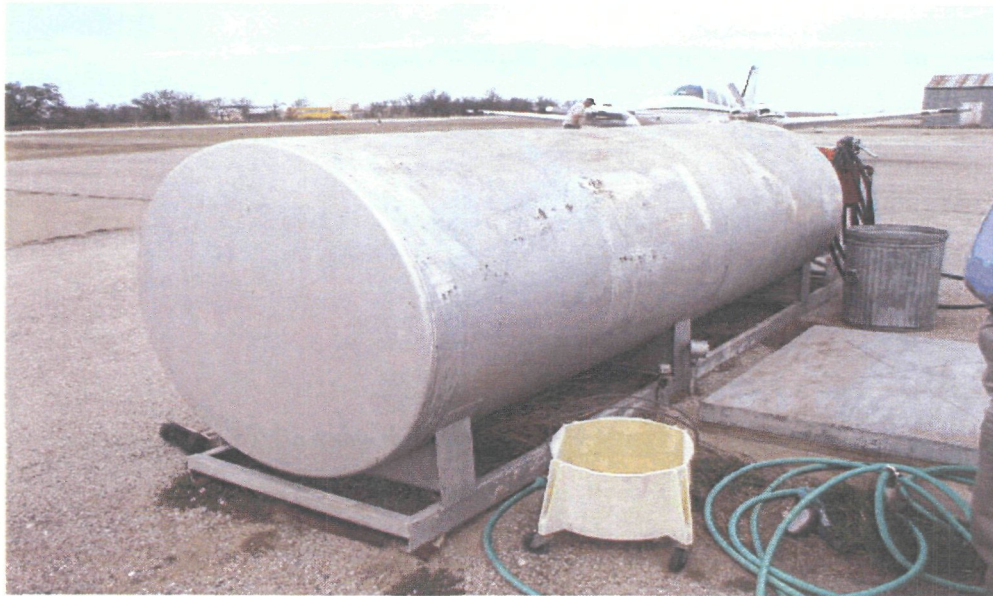
Picture 13 Parker County Airport aboveground storage tank located next to the well#2
Facing northwest, picture was taken by Xiaohong Wang on March 6, 2007

Because there is no historical information available for the underground storage tanks located next to the well and currently the tanks are out of the service, further investigation for the area is needed.

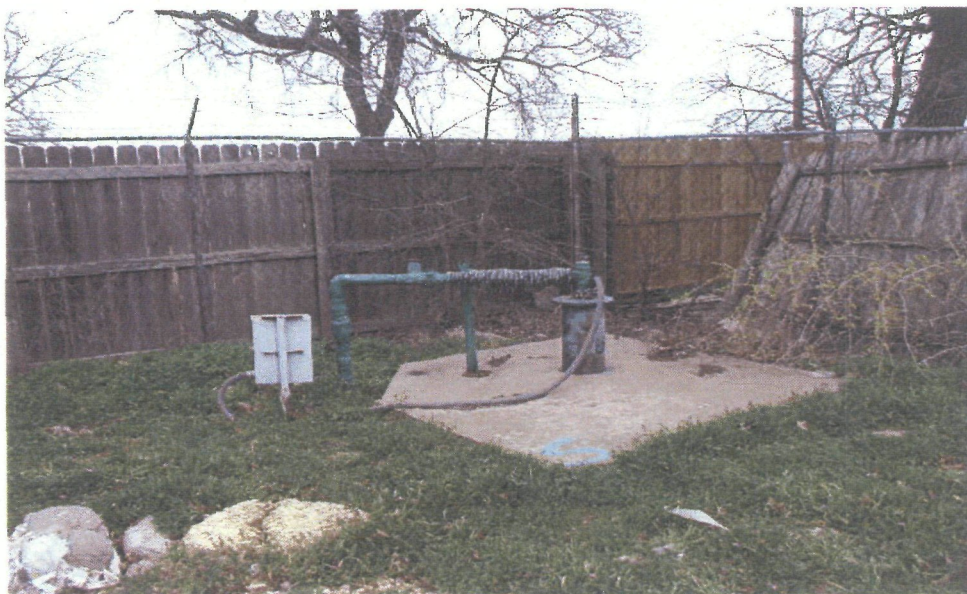
Picture 15 North well located at POE 010 of Willow Springs Pump Station
Facing northwest, picture was taken by Xiaohong Wang on March 6, 2007

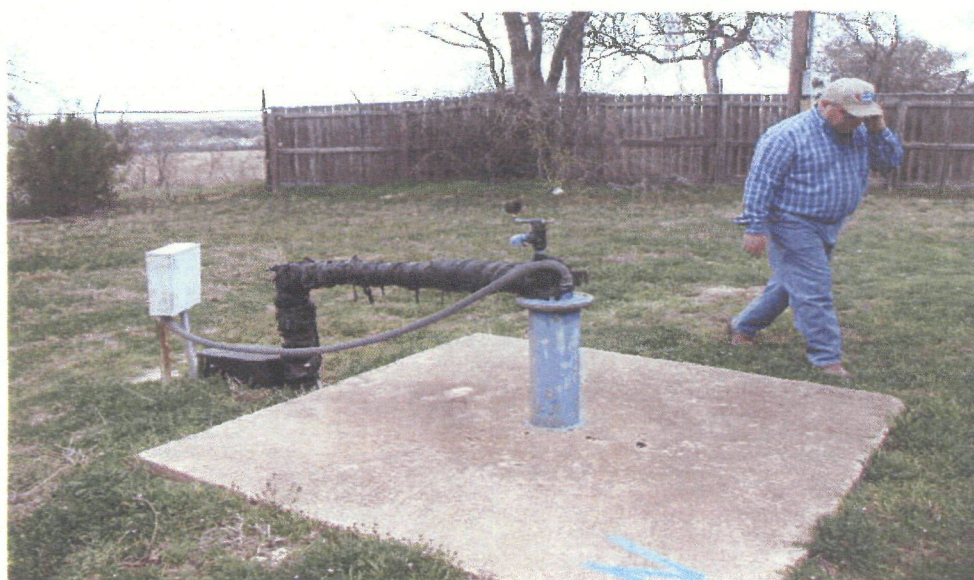
Picture 16 South well located at POE 010 of Willow Springs Pump Station
Facing southwest, picture was taken by Xiaohong Wang on March 6, 2007

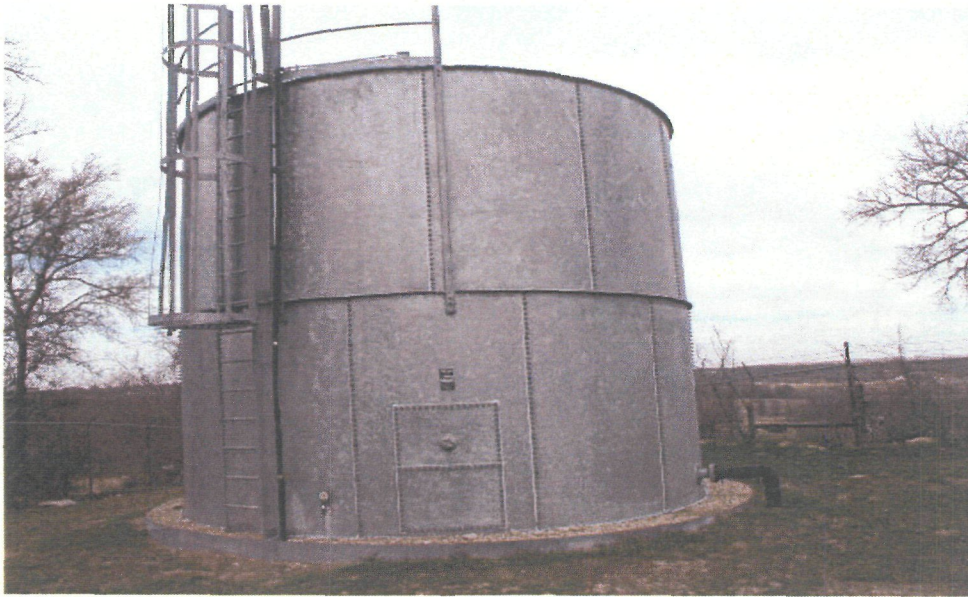
Picture 17 Aboveground tank located at Willow Springs Pump Station
Facing the west, picture was taken by Xiaohong Wang on March 6, 2007

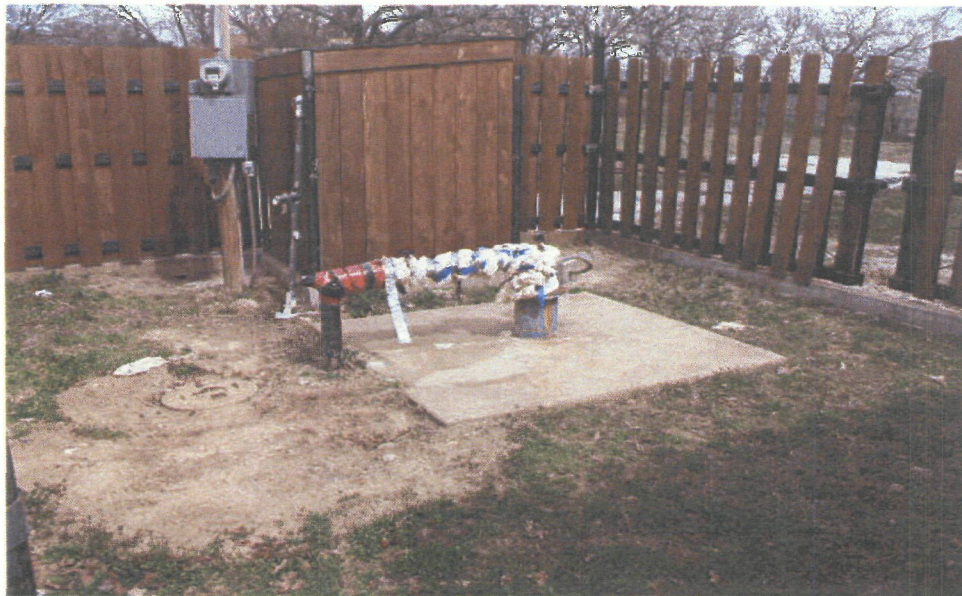
Picture 18 Well 11 for POE 008
Facing north, picture was taken by Xiaohong Wang on March 6, 2007
